Clock Spring

Qualification data

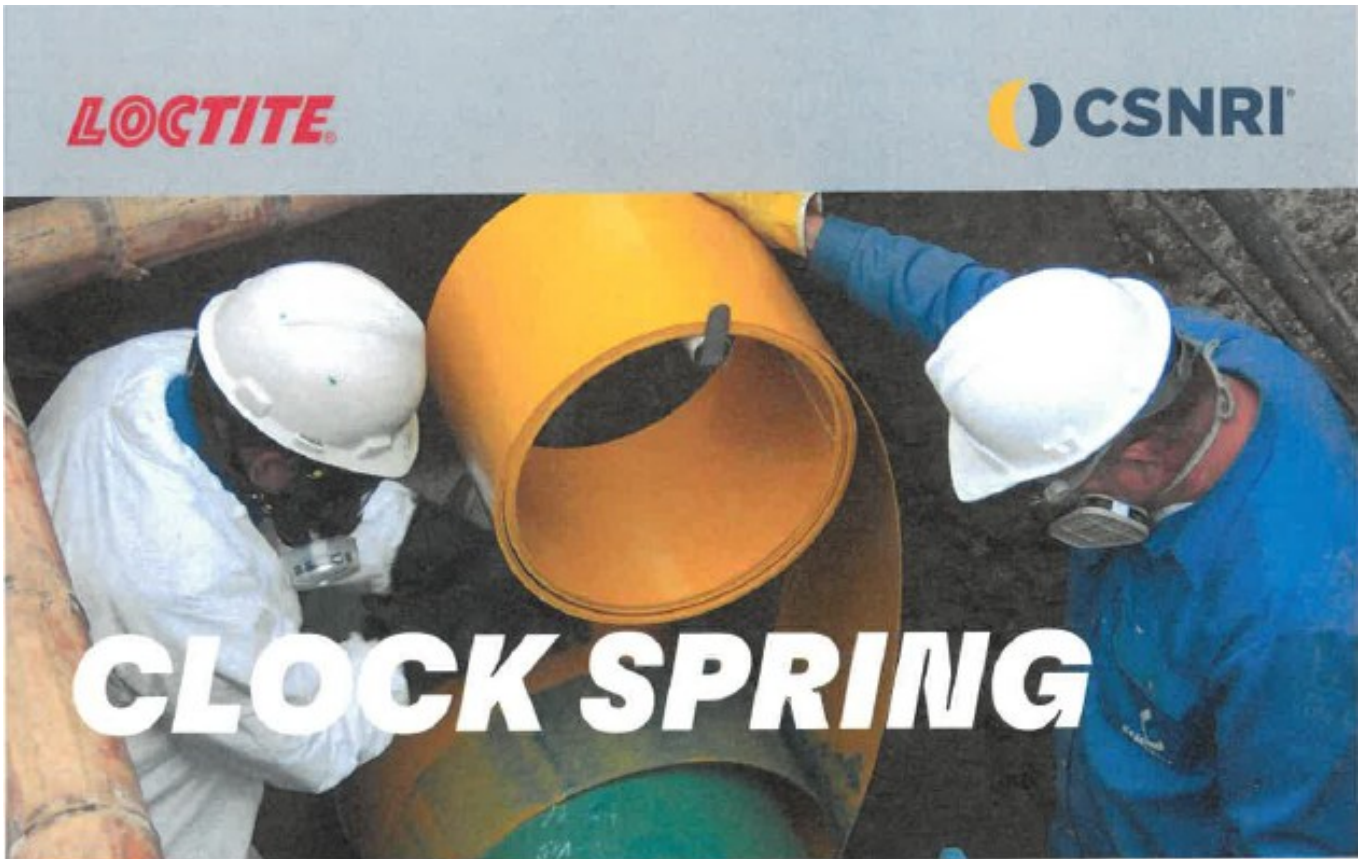
The Clock Spring composite repair sleeve and reinforcement system is uniquely designed for high pressure transmission pipelines. Made up of a pretensioned and pre-cured unidirectional e-glass composite coil, a high-modulus filler material, and a high lap-shear strength methyl methacrylate adhesive, it is proven to 8000 psi burst pressure, has a design life of beyond 50 years, and an installation history of more than 30 years, qualifying it as the first permanent repair in the industry.

Each Clock Spring coil is made up of 8 layers, providing a repair with a higher failure pressure than the original pristine pipe. Designed to structurally reinforce and permanently restore external anomalies to beyond original pipe strength, the Clock Spring sleeve can repair a broad range of metal loss up to 80% depth, deformation and mechanical damage, and mill defects. Clock Spring is available in 4-inch through 56-inch diameter kits.
